FINAL REPORT

UNDERWATER TESTING OF STAINLESS STEEL BOXES 1210-E-61

Universal Match Corporation Maynard Armament Division Post Office Box 25 Maynard, Massachusetts

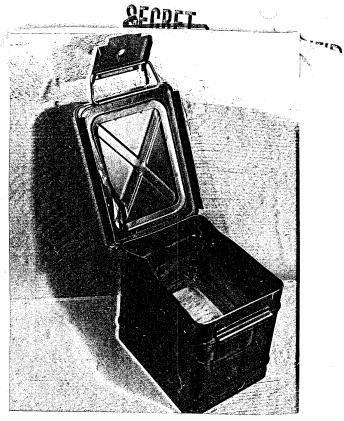
Examination showed that the 8" can was full of water due to one side buckling in and no longer mating with the gasket (See Photograph). The 50° can, however, was perfectly dry and it appears that the greater length allowed the collapse without interrupting the seal at the gasket (See Photograph).

Figure 1 8" Can After Collapse

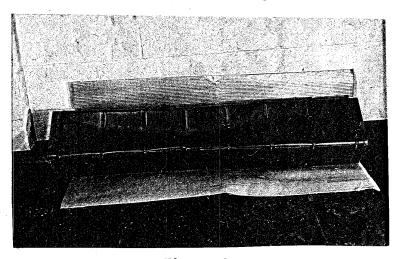
Figure 2 15" Can still vatertight despite deep dishing.
